# Just Can't Stop

**A Florida contractor uses cured-in-place pipe to rehabilitate machine drainage lines in a potato chip processing plant**

**Line three severely occluded drain pipes over a weekend**

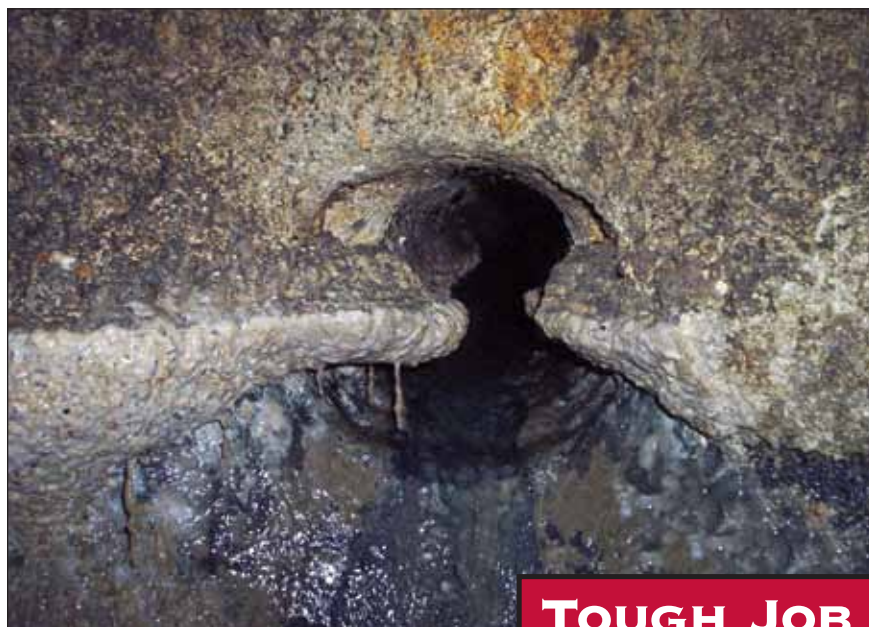
**The 8-inch sewer main had no invert and was occluded with grease, lime deposits, rust buildup, and corrosion.**

“That was my first view of the extent of the problem,” says McFall. “The invert was missing from five to seven o’clock, and the crown of the pipe was packed with grease. The combination of grease, lime deposits, rust buildup, and corrosion on the sides occluded three-quarters to seven-eighths of the inside diameter.

The 8-inch line was rehabilitated in two shots, 80 feet and 36 feet long. The men used the access pit to line the downstream leg first, then shot the upstream section from the manhole. “The upstream liner overlapped the downstream one by 12 inches, making a smooth transition and eliminating a lip on which solids could catch,” says McFall.

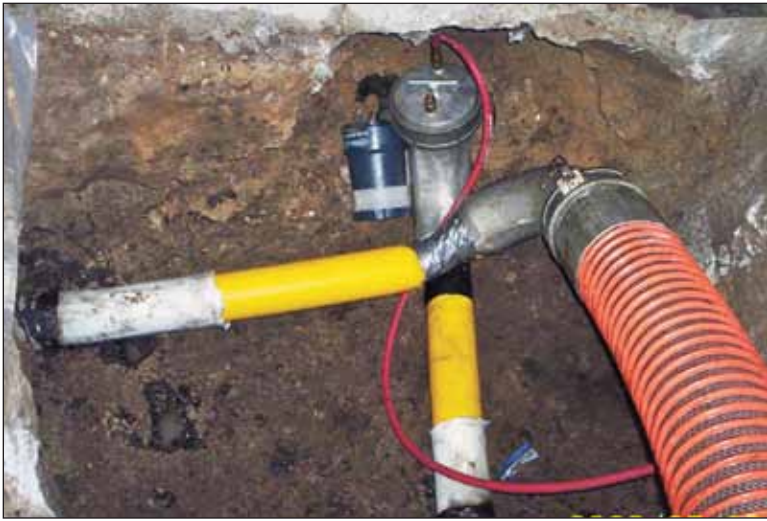
Workers lined in both directions from the access point in the 184-foot-long 4-inch pipe, shooting 101-foot and 83-foot liners.

The 8-inch liners were inverted at 12 psi, then cured at 8 psi for three hours. They blew around the bends without difficulty. The 184-foot-long 4-inch pipe was lined in 101- and 83-foot shots, following the same procedure. “We increased the pressure to 15 psi to nudge the liner round the bends, then lowered it to 7 psi,” says McFall.
